Mercury Lamp
Drum-Top Crusher
Study

TABLE OF CONTENTS

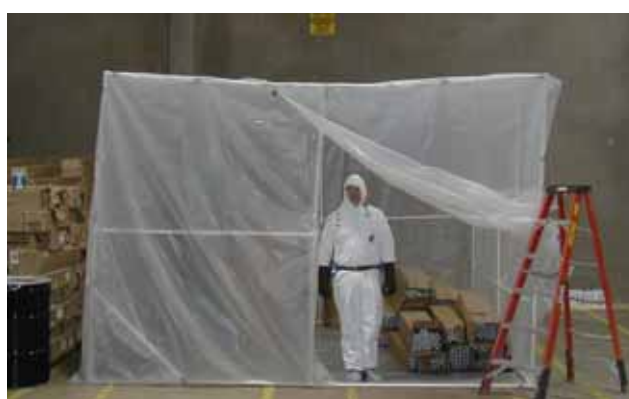
Photograph 2.2: EPSI Phoenix Facility - Containment Structure

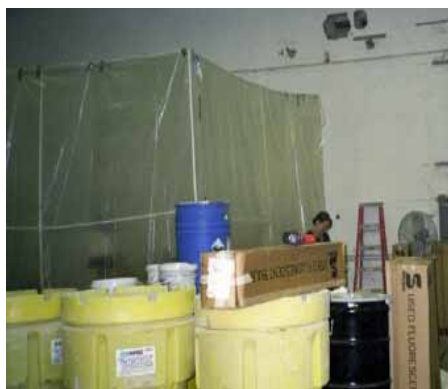
Photograph 2.3: AERC Melbourne Facility - Containment Structure

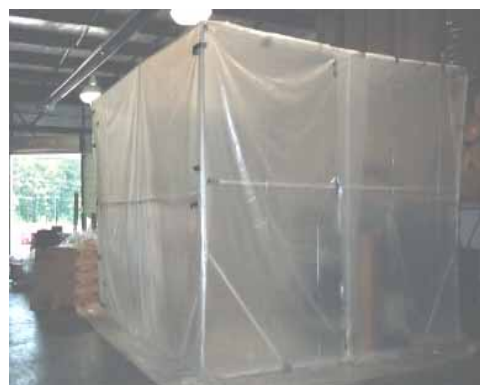
Photograph 2.4: AERC Ashland Facility - Containment Structure - Second Visit

The polyethylene walls, floor, and ceiling were changed before testing each device at each location. The containment structure used a “flap” door to allow entry and exit by the operators. This door, which overlapped the walls, limited the amount of air exchanged between inside and outside the containment structure; however, it was not possible to entirely eliminate air exchanges.

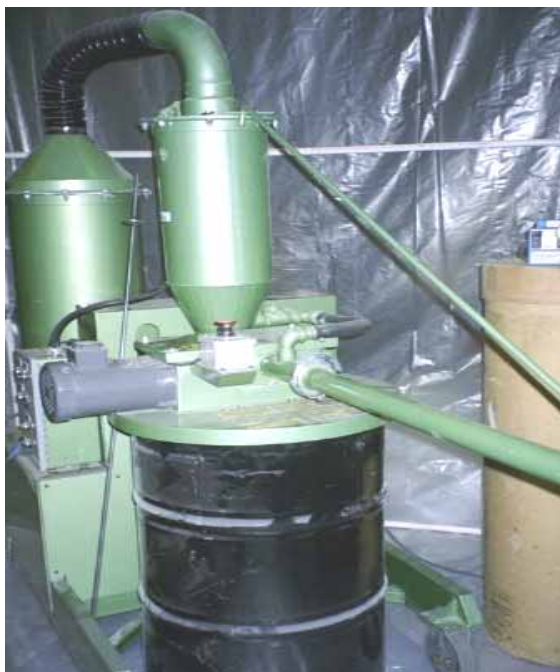
Photograph 2. 5: Manufacturer A Device

- Manufacturer A (*Photograph 2. 5*)
- Manufacturer B (*Photograph 2. 6*)
- Manufacturer C (*Photograph 2. 7*)
- Manufacturer D (*Photograph 2. 8*)

All manufacturers except Manufacturer A provided new, unused DTC devices for the Study. Manufacturer A provided a prototype machine that was used prior to the Study, but was cleaned and decontaminated by the manufacturer before it was sent for testing in the Study. For reasons that are discussed in Section 3.5.1 of this report, the Manufacturer D device was tested only during Phase I of the PVS and the first round of the EFTS.

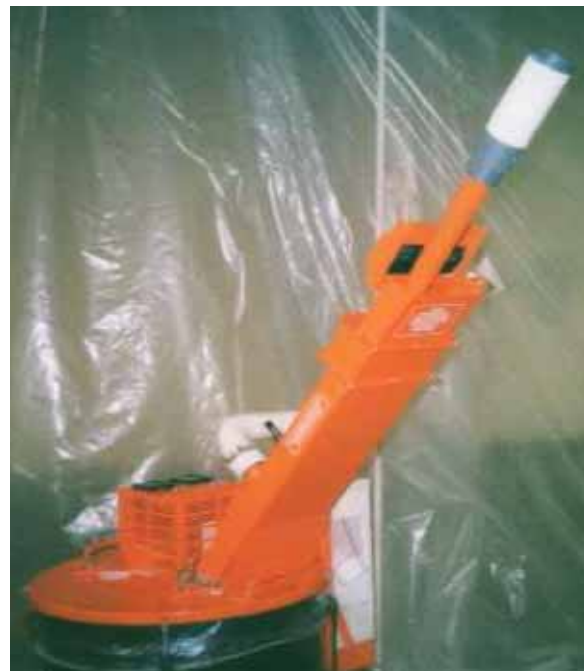
Photograph 2. 6: Manufacturer B Device

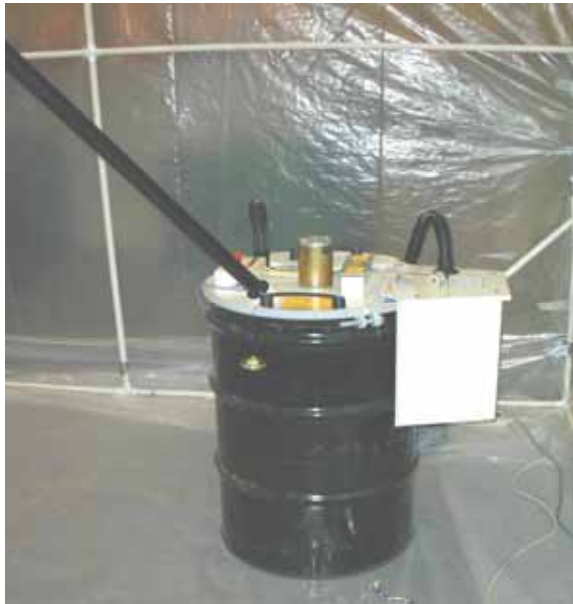
Photograph 2.7: Manufacturer C Device

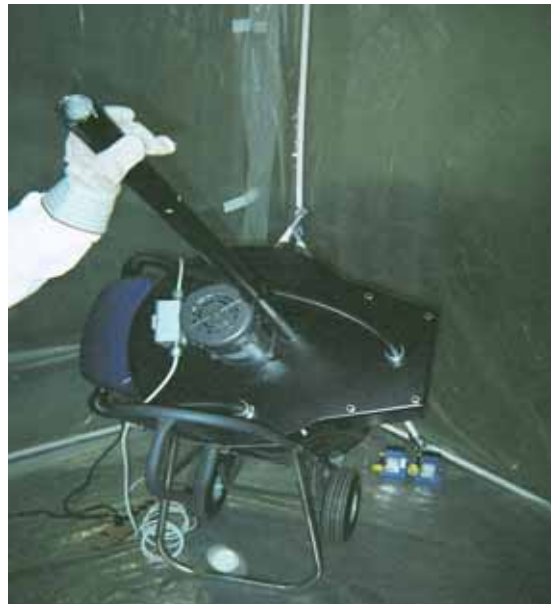
Photograph 2.8: Manufacturer D Device

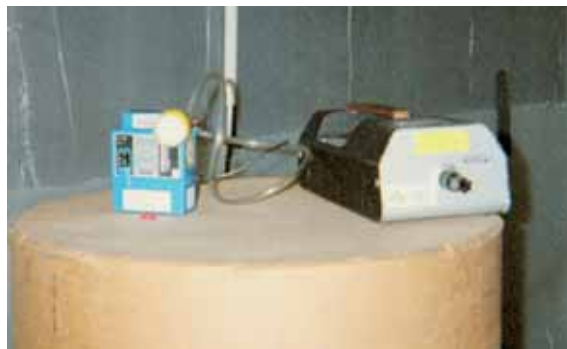
Photograph 3. 1: Air Sampling Pumps and Jerome Mercury Vapor Analyzer

Air samples were collected in the operator's breathing zone during normal operation, filter changes and drum changes, and in selected locations within the containment structure. Jerome measurements were taken both inside and outside the containment structure. Photograph 3. 1 shows the air sampling pump and Jerome analyzer inside the containment structure.

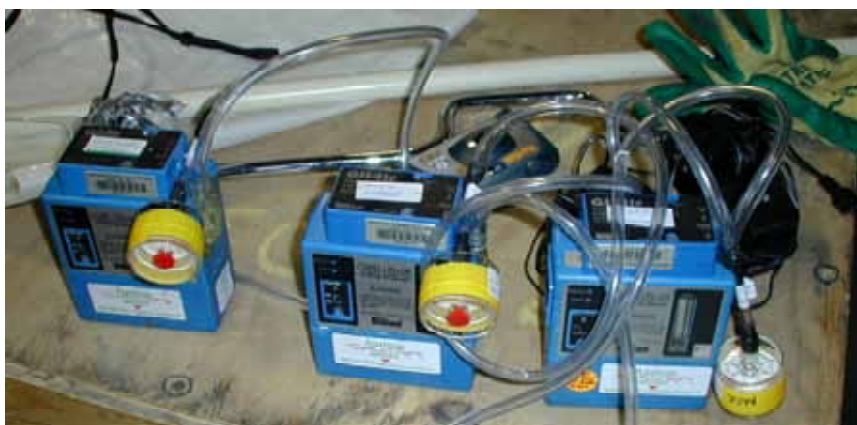
Photograph 3. 2: Sensidyne Air Sampling Pumps

Air samples were collected by drawing known volumes of air through the sampling media using Sensidyne GilAir 5RC air sampling pumps equipped with multi-flow adapters (*refer to Photograph 3. 2*).

The Sensidyne pumps were calibrated on site both before and after use, according to the manufacturers' specifications, using the BIOS DC-Lite calibrator as a primary standard. The calibration data are contained in Appendix B. During calibration, the

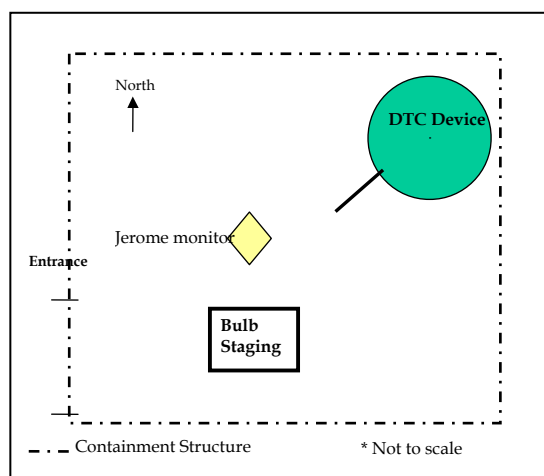
Figure 3. 4: Box Test Configuration, AERC Melbourne

During Phase I of the PVS and EFT #1 and the beginning of EFT #2, multiple cardboard boxes of fluorescent lamps were brought into the containment structure and kept inside to ensure that the operator had an adequate supply of readily accessible lamps. The field team suspected that the mercury released from the broken lamps in the boxes was contributing to elevated levels inside the containment structure. Based on this concern, testing procedures were revised so that only one box of lamps was kept inside the containment structure.

At the end of the week, the decision was made to repeat a portion of the Manufacturer B device testing, following the new procedure of bringing only one box at a time into the containment structure. Due to time constraints, the repeat test included only one drum, not two drums as in the first test at this location.

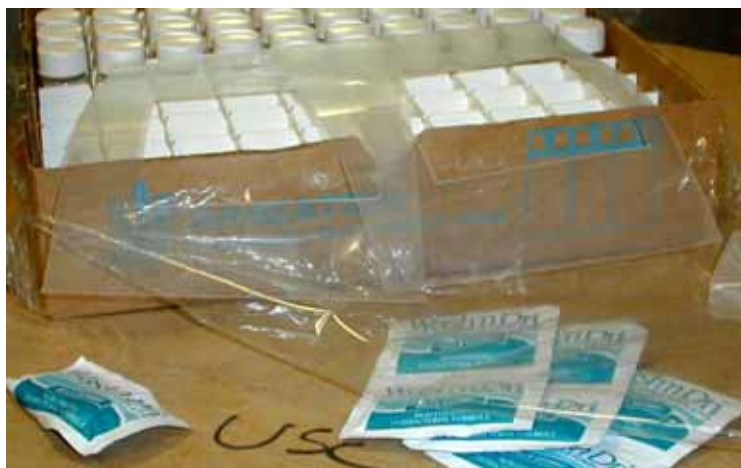
Photograph 3. 8: Wipe Sample Media

Surface wipe samples were collected inside the containment structure on numerous surfaces both before and after lamp crushing, as part of the Mass Balance Study. The wipe samples were collected and analyzed in accordance with N9103 for wipe samples (*refer to Appendix E*). Under this procedure, a 100 square centimeter (cm²) area was wiped using a "Wash N' Dri" towelette (the liquid component of the wipe is 5 to 10 percent ethanol and 80 to 90 percent water), which was placed into a glass vial. Wipe sample supplies were provided by Data Chem (*refer to Photograph 3. 8*).

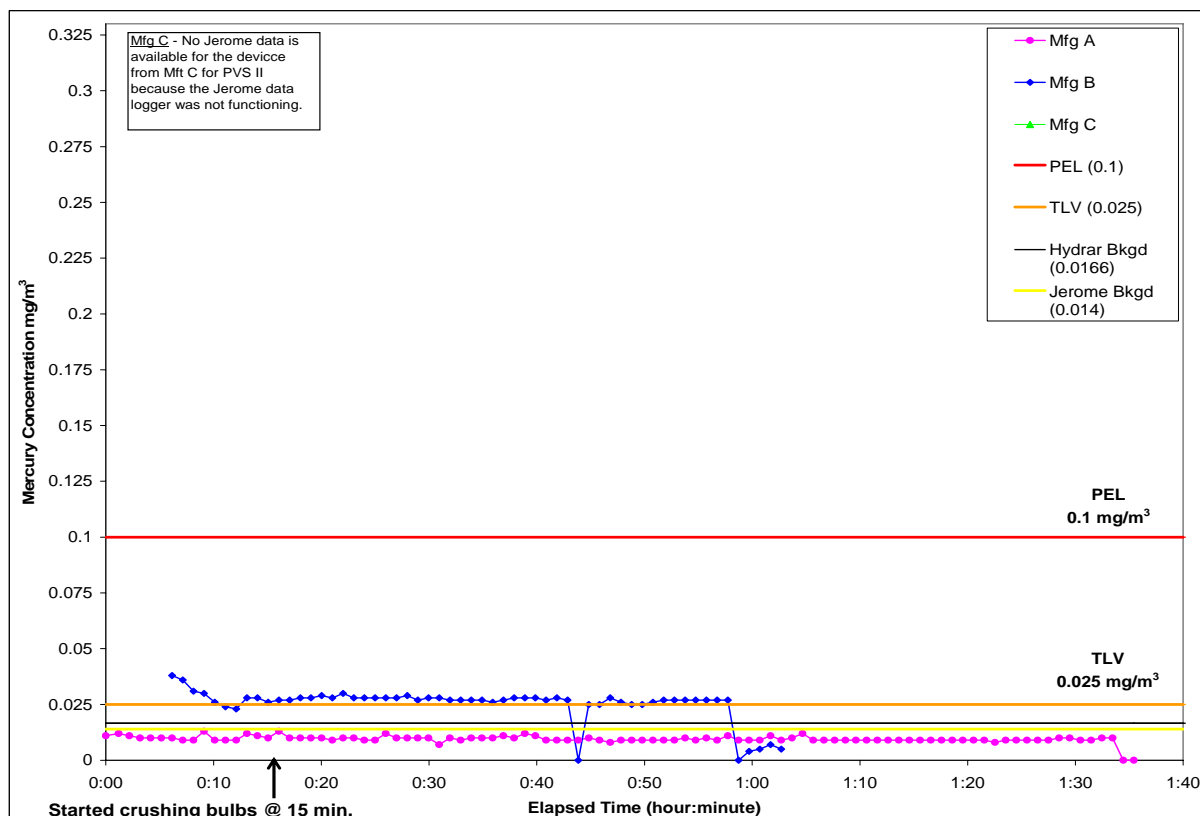
Figure 4. 3: Jerome Results - Inside Containment, Performance Validation Study II^a

^a The TLV is included on the graph as a point of reference. The mercury concentrations shown on this graph represent instantaneous measurements and do not represent eight-hour TWAs.

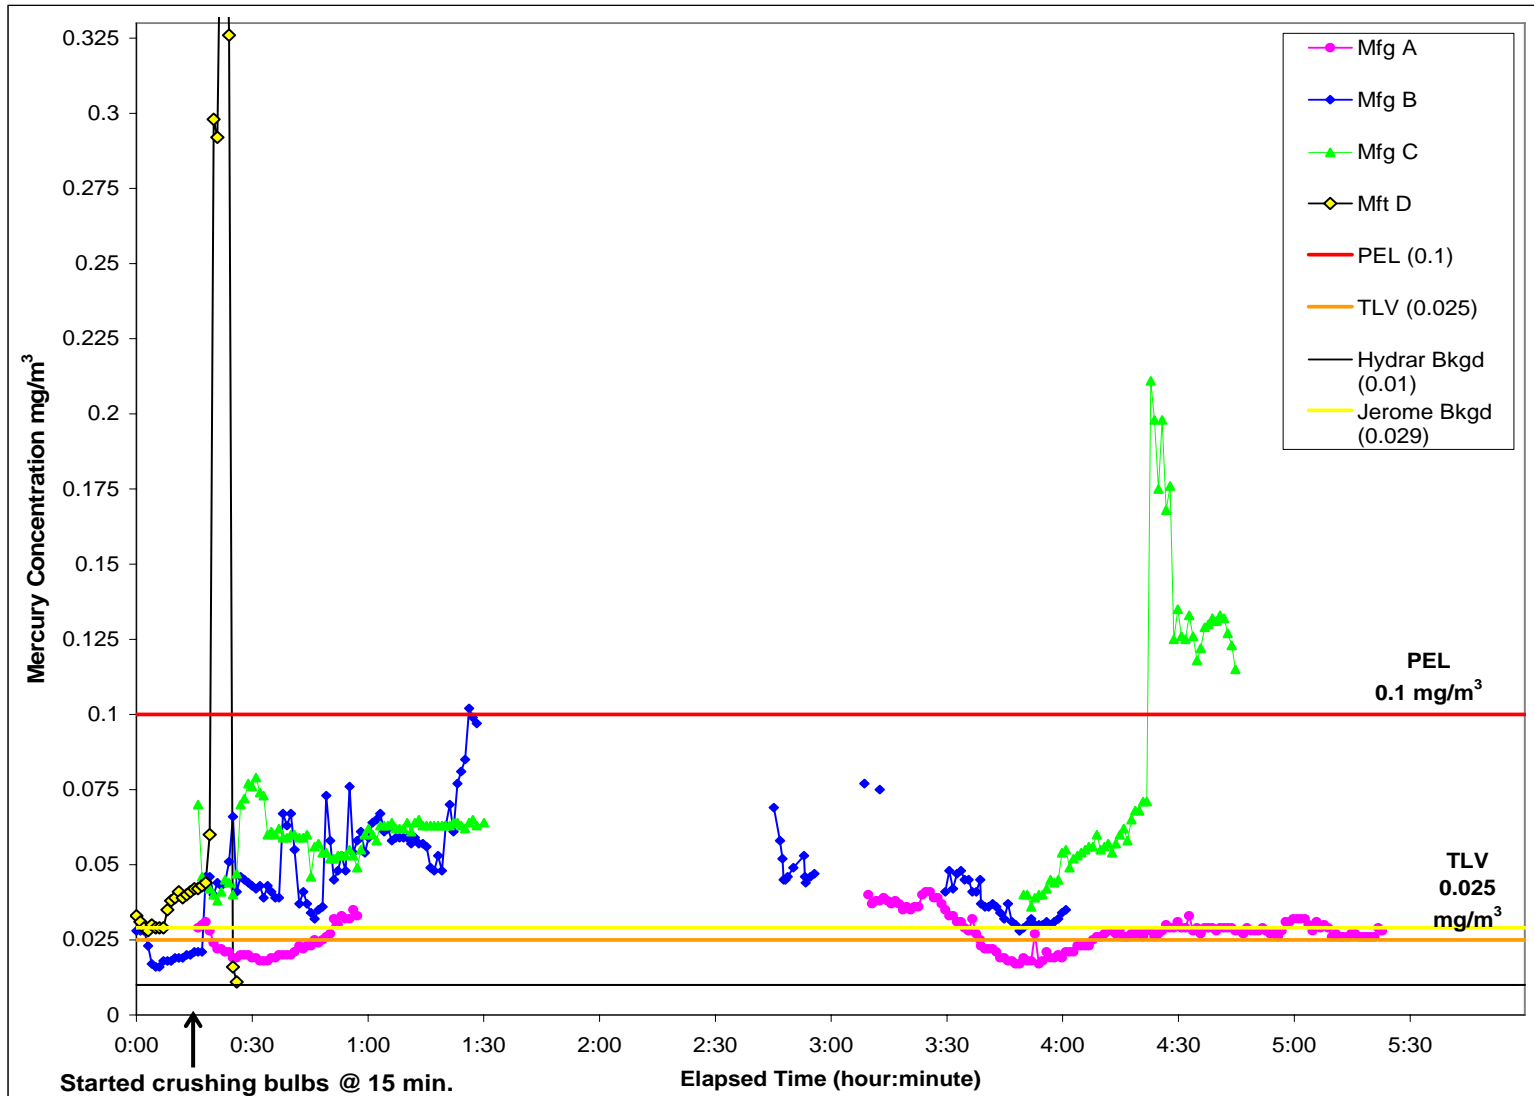
Figure 4. 6: Jerome Results - Inside the Containment, Extended Field Test #1^a

^a The TLV is included on the graph as a point of reference. The mercury concentrations shown on this graph represent instantaneous measurements and do not represent eight-hour TWAs.

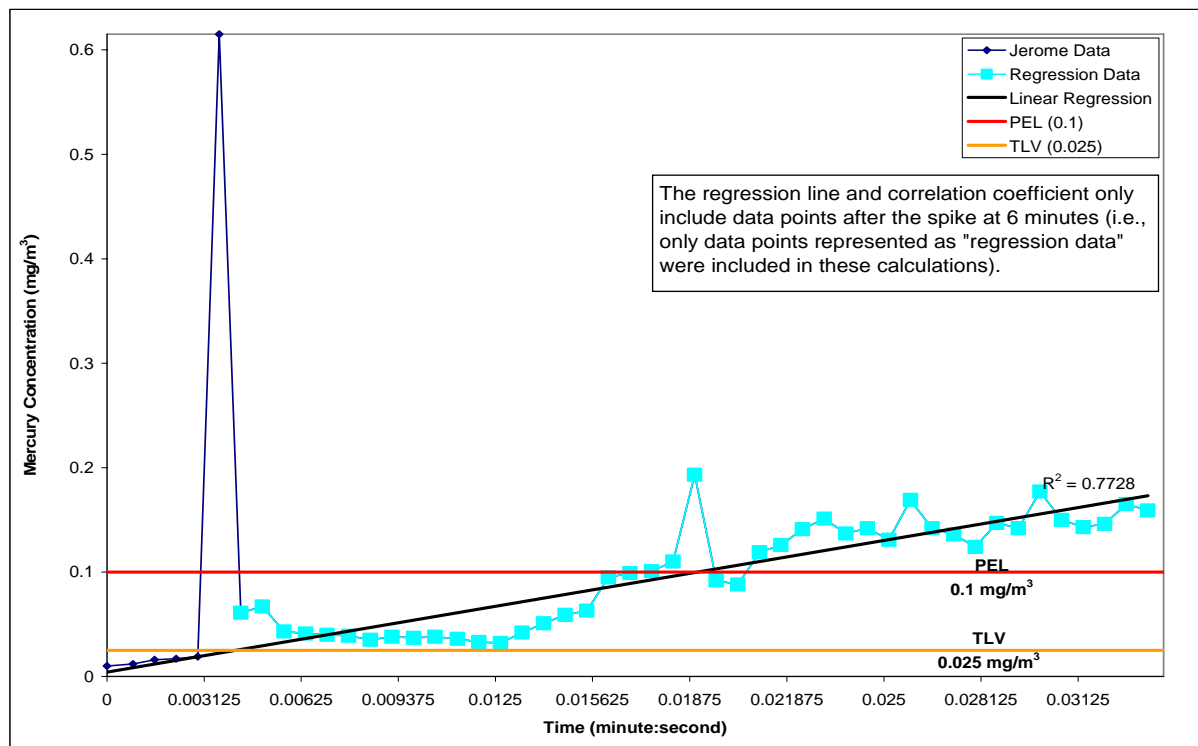
Figure 4. 14: Jerome Results - Inside Containment, AERC Melbourne Box Test ^a

^a The TLV is included on the graph as a point of reference. The mercury concentrations shown on this graph represent instantaneous measurements and do not represent eight-hour TWAs.

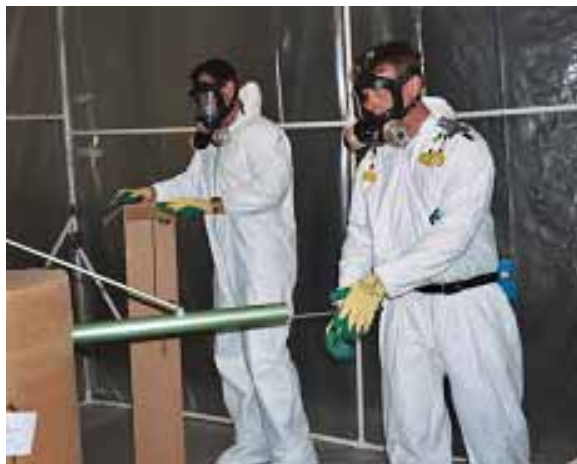
Photograph 7. 1: Clearing Jammed Feed Tube of Manufacturer A Device
